CALSPAN ON-SITE SCHOOL BUS/PEDESTRIAN ACCIDENT INVESTIGATION

CALSPAN CASE NO. 95-14/3

SCHOOL BUS: 1992 INTERNATIONAL CHASSIS/AM TRAN (WARD) BODY

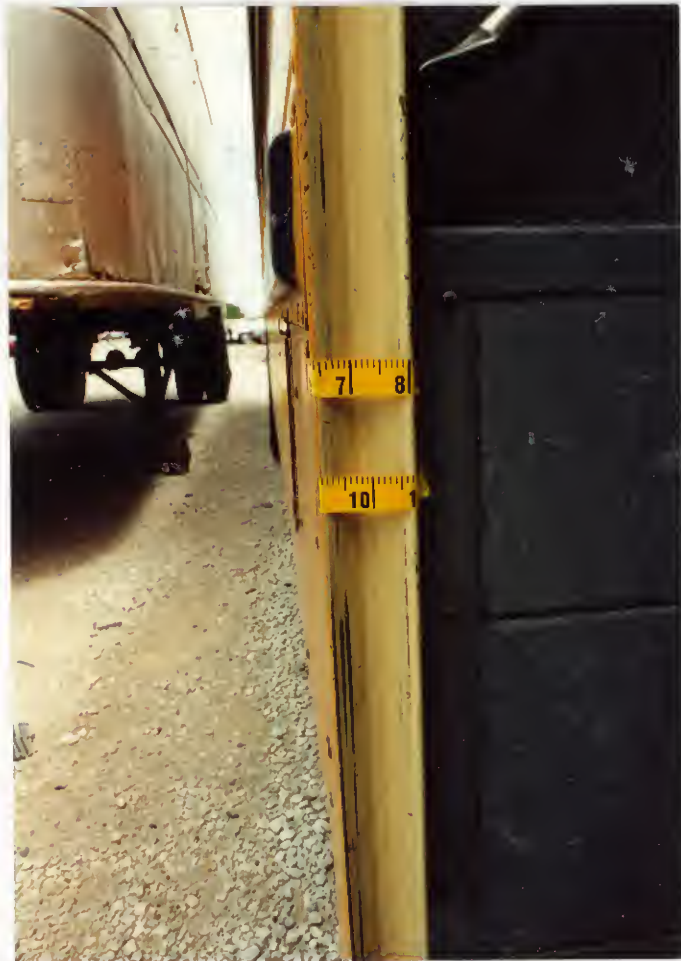
25. Possible area where the drawstring tab was caught between the door and the V-channel.

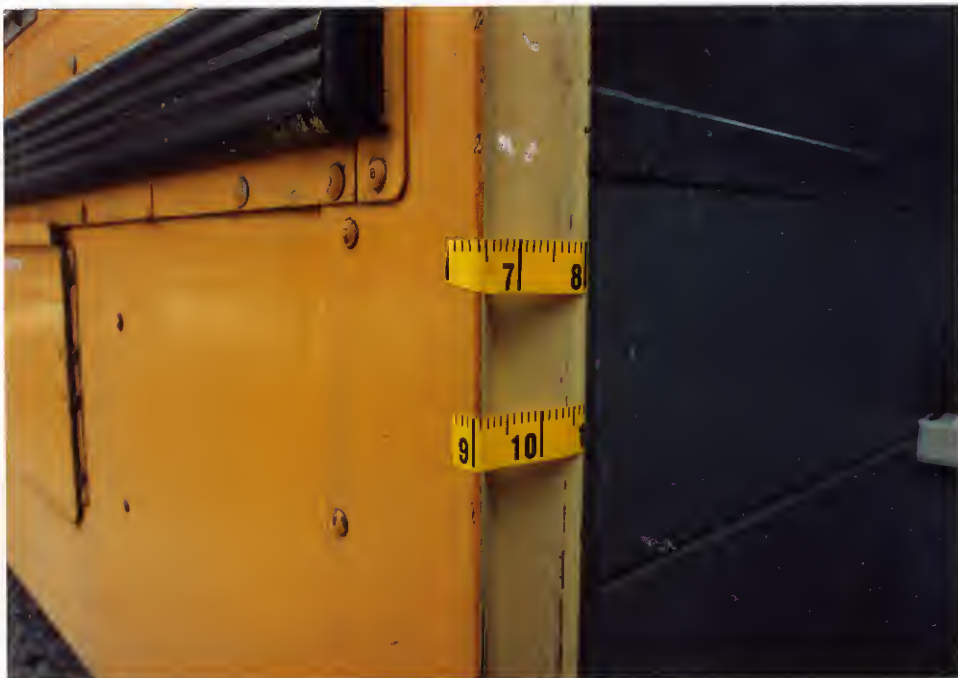
There was no distinct evidence on the bus components of loading or snagging of the drawstring. The edge of the rubber door gasket was straight with numerous abrasive type marks in multiple directions. The V-channel was not gouged or marked from the plastic drawstring tab. There was a fabric-type wipe mark on the exterior yellow painted surface of the V-channel located 32.125-33.375" above the ground. The wipe mark extended 0.25" rearward from the edge of the channel (refer to Photograph No. 26).

26. Faint fabric-type (patterned) wipe mark on right side surface of bus.

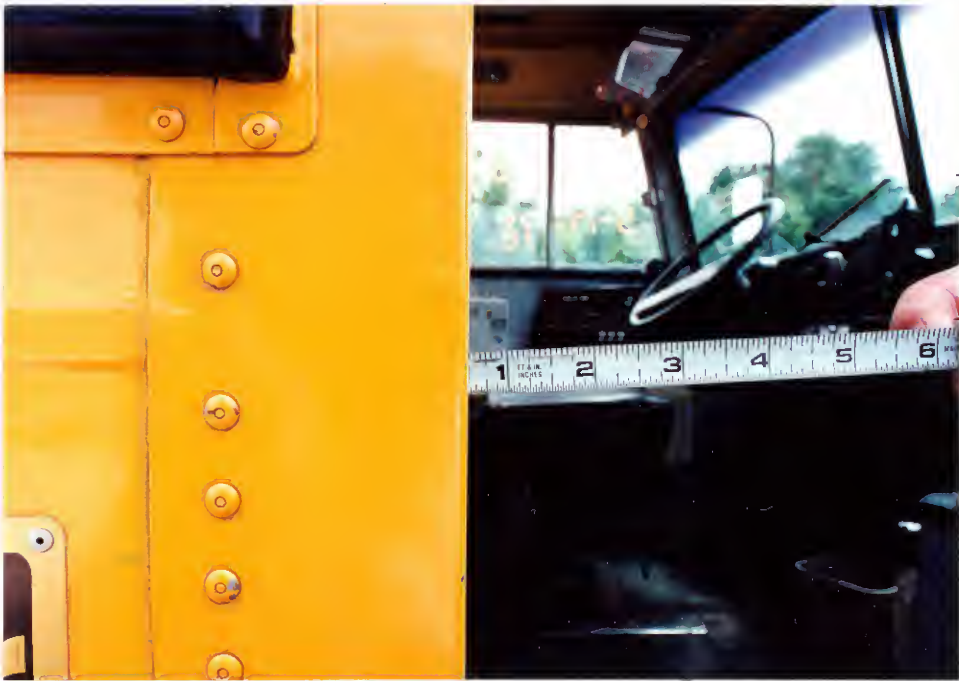
27. Depth ($17/32$ ") of the V-channel.

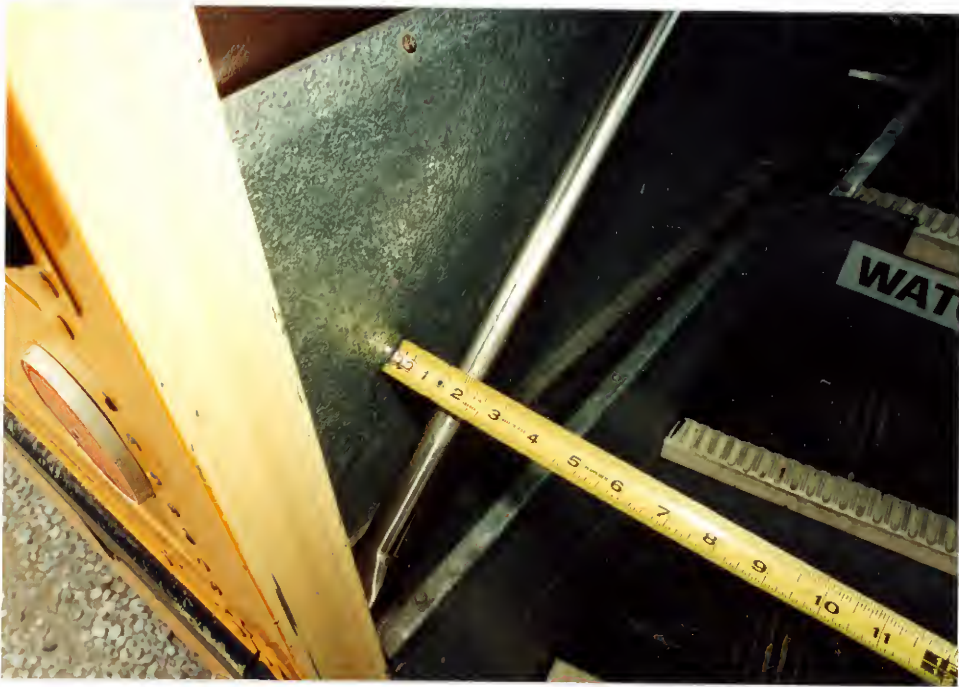
33. Lateral offset between the handrail and the modified placement of the kick panel.

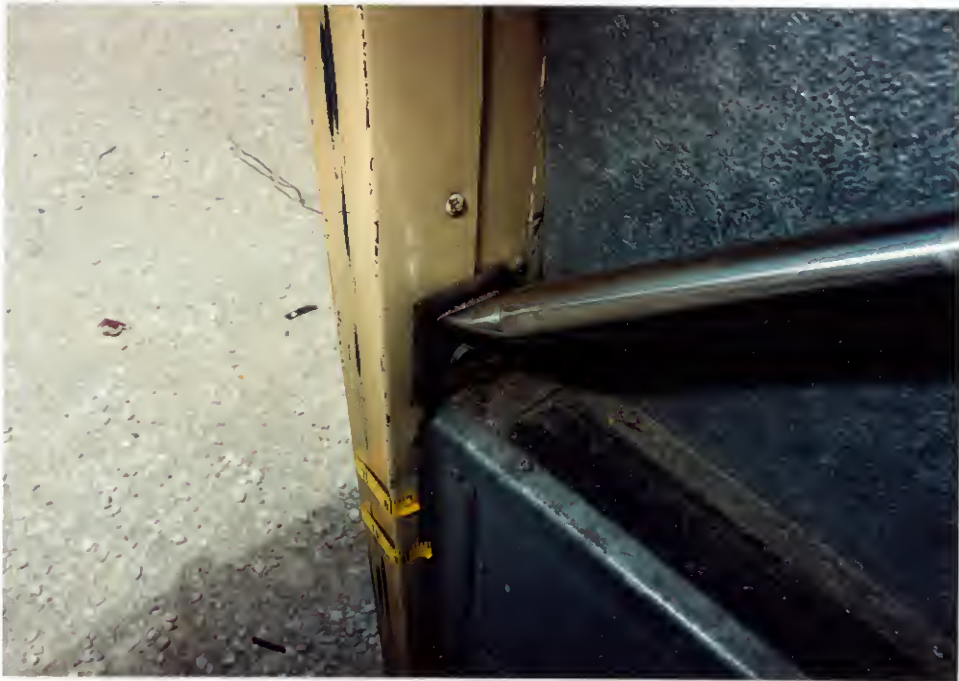
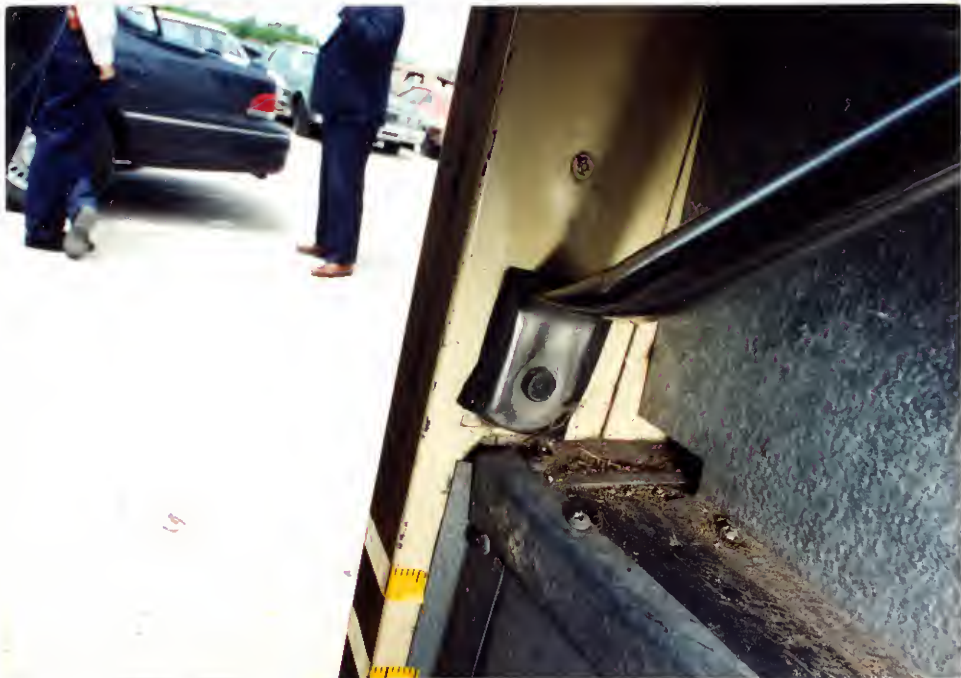
The accident involved school bus had been modified by the contractor prior to this incident. A 2" horizontal x 2.5" vertical soft foam rubber pad was placed between the base of the handrail and the side surface of the bus. In the area of the handrail flange, the foam was completely compressed. The upper edges of the foam pad protruded beyond the handrail flange which was designed to deflect objects (drawstrings, etc.) away from the handrail/sidewall juncture. The installation of the rubber pad is documented in Photograph Nos. 35-37.

35 & 36. Lower attachment point of the handrail with the modified foam rubber pad installed.

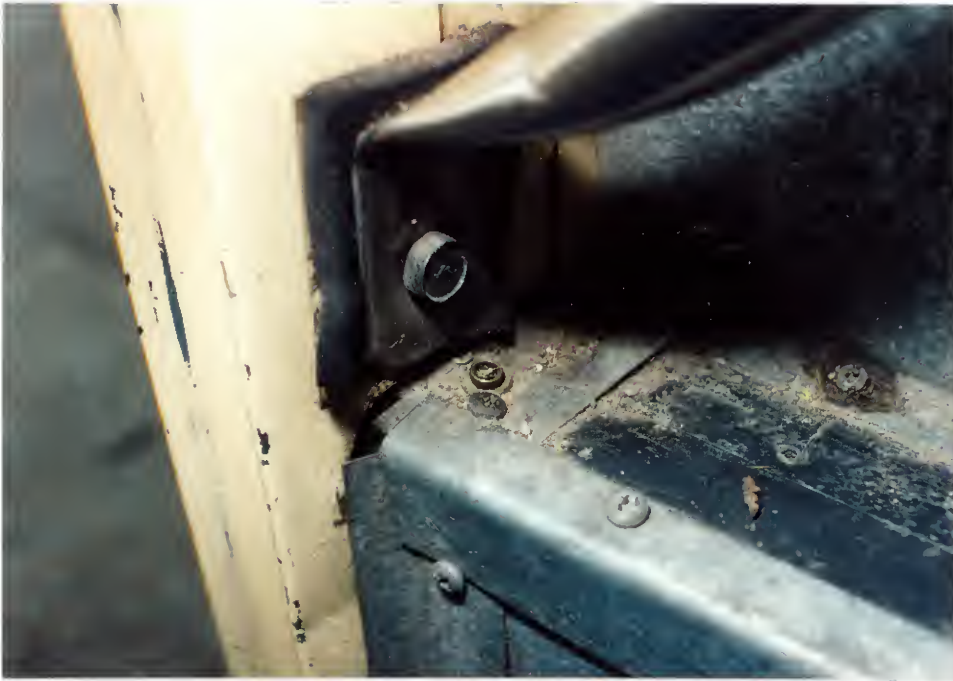
The floor of the school bus extended from the vertical wall at the stairwell to the modesty panel and formed a shelf under the handrail. This shelf was approximately 23.25" in length and tapered from a width of 3.25" at the right B-pillar area to a width of 2.125" at the top of the stairs. During the inspection of the bus, a metallic snap from a clothing item was found on this shelf in the debris against the V-channel/B-pillar area, directly under the lower handrail attachment point. The snap was not related to this accident (refer to Photograph No. 37).

37. Close-up view of the lower attachment point and the installed foam rubber pad. (Note the snap at the base of the handrail attachment point; probably resulted from a previous clothing snag with the handrail.)

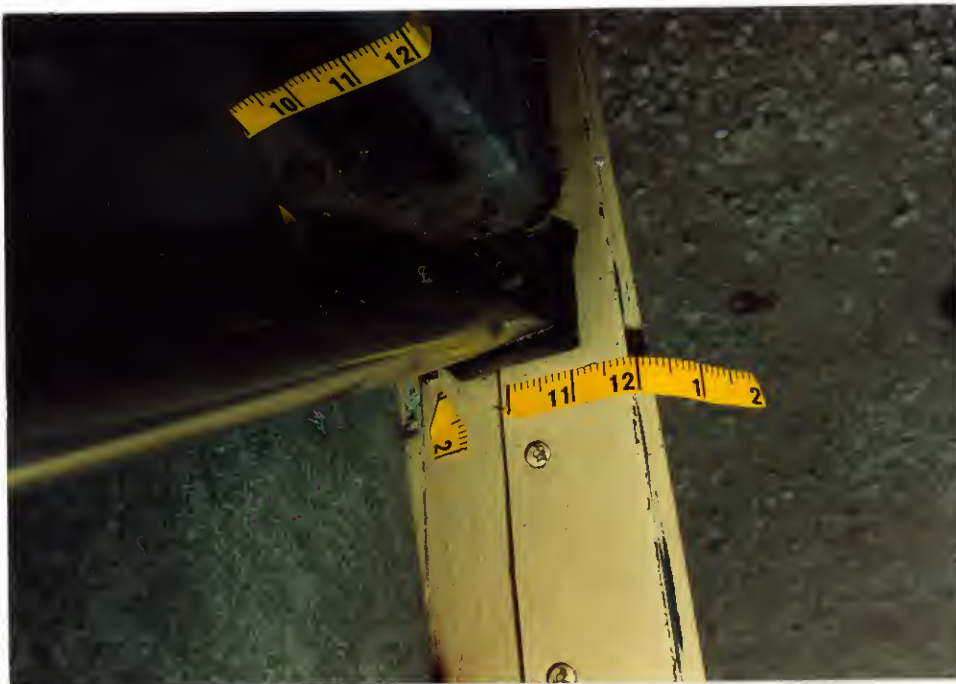
38. Offset between the handrail and the V-channel at the trailing edge of the door opening.

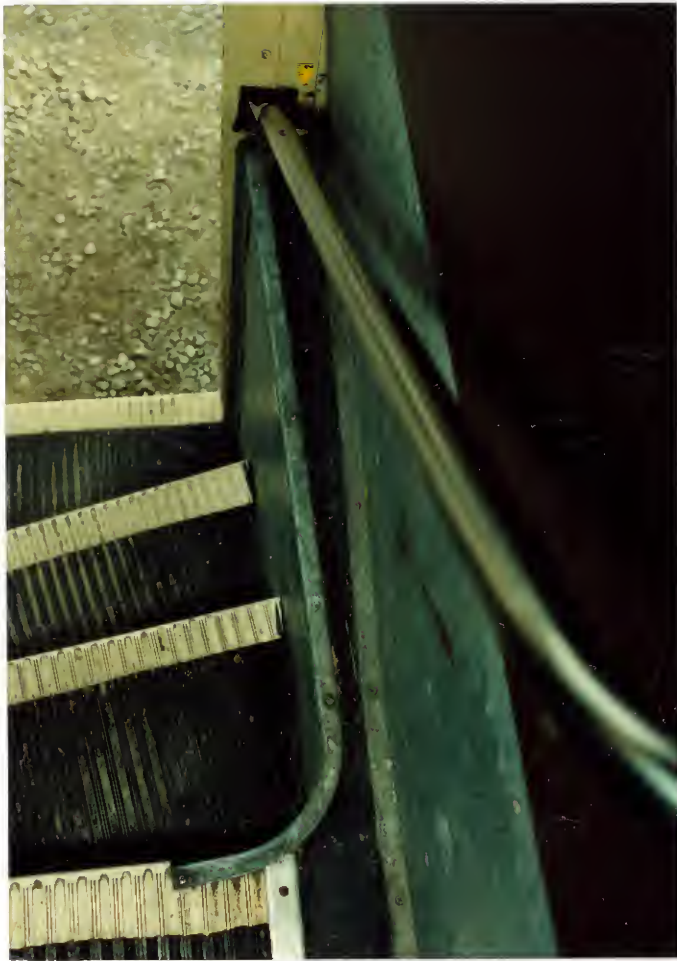
The base of the modesty (kick) panel had also been repositioned by the bus contractor prior to this accident. This was evidenced by the holes in the floor and sidewall from the initial installation of the panel. It should be noted that only the base of the modesty panel had been repositioned as identified in the recall notice and not the entire crash barrier unit. The right outboard edge of the modesty panel (vertical edge) had been repositioned 1.25" rearward of the original attachment point. The original sheetmetal screw hole (#6 or 8 screw) was located 3.25" rearward of the V-channel and 2.375" above the floor level of the bus. This original screw hole was not plugged or protected and contained several heavy burrs around the perimeter of the hole. The bottom edge of the panel was affixed to the floor of the bus with four sheetmetal screws. The outboard screw had been repositioned 1.125" rearward while the second and third screws were repositioned 13/16" and 0.375" rearward respectively. The inboard fourth screw was either repositioned a scant amount or remained in its original position as the bottom flange covered the original position. The modification to the modesty panel is documented in Photograph Nos. 39-43. The lateral offset (clearance) between the handrail and the modesty panel was approximately 1 3/16" at the mid point of the panel.

39. Longitudinal view of the modified placement of the lower kick panel.

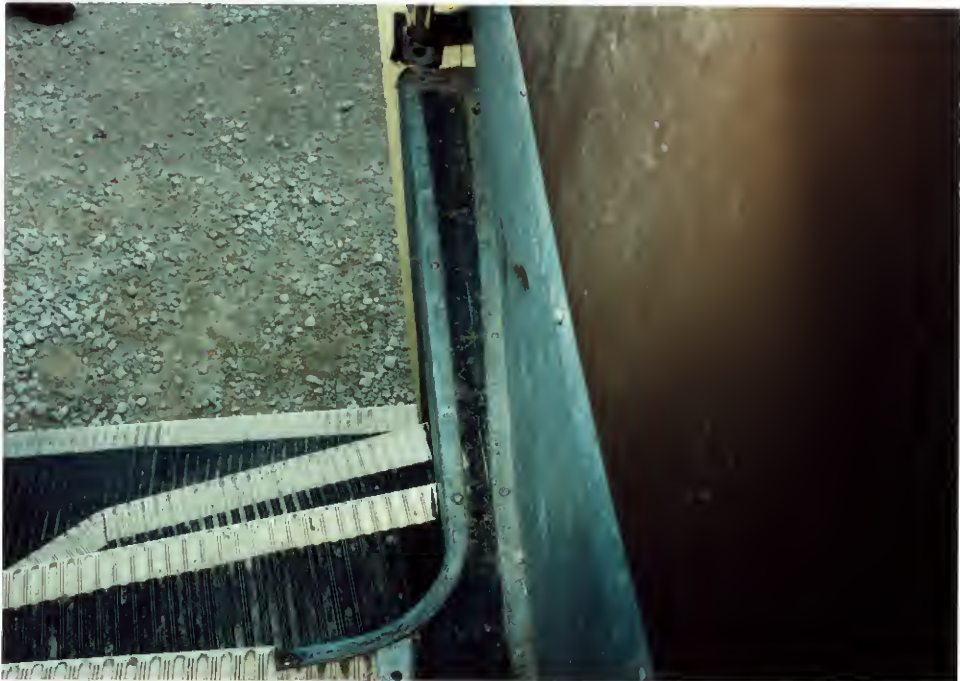
40. Visible line highlighted with yellow arrows indicates the original placement of the kick panel.

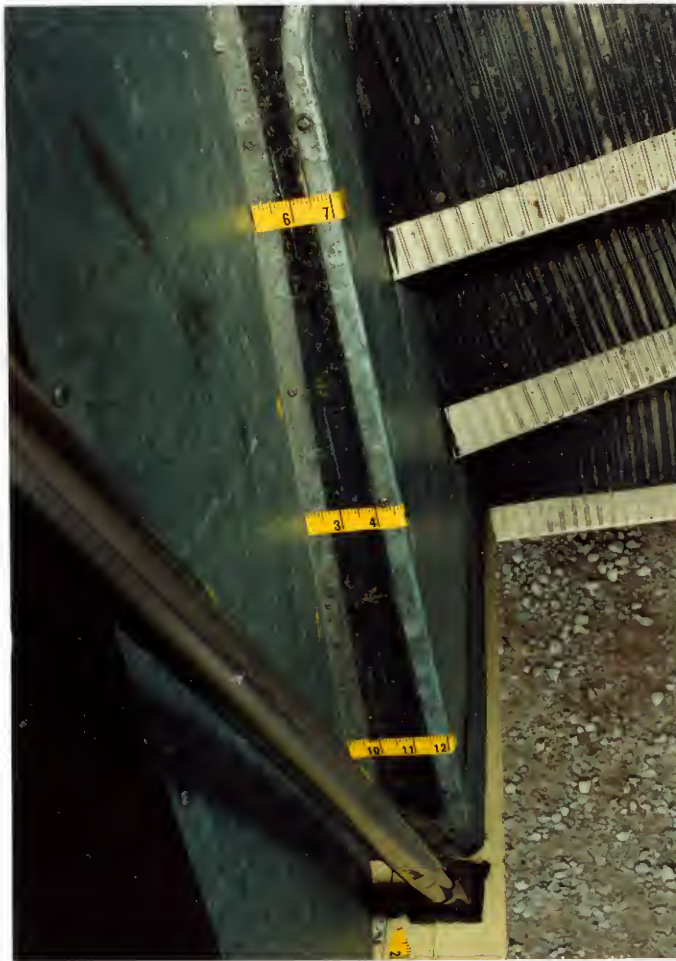
41. Calibrated tape documents the distance that the kick panel had been repositioned.

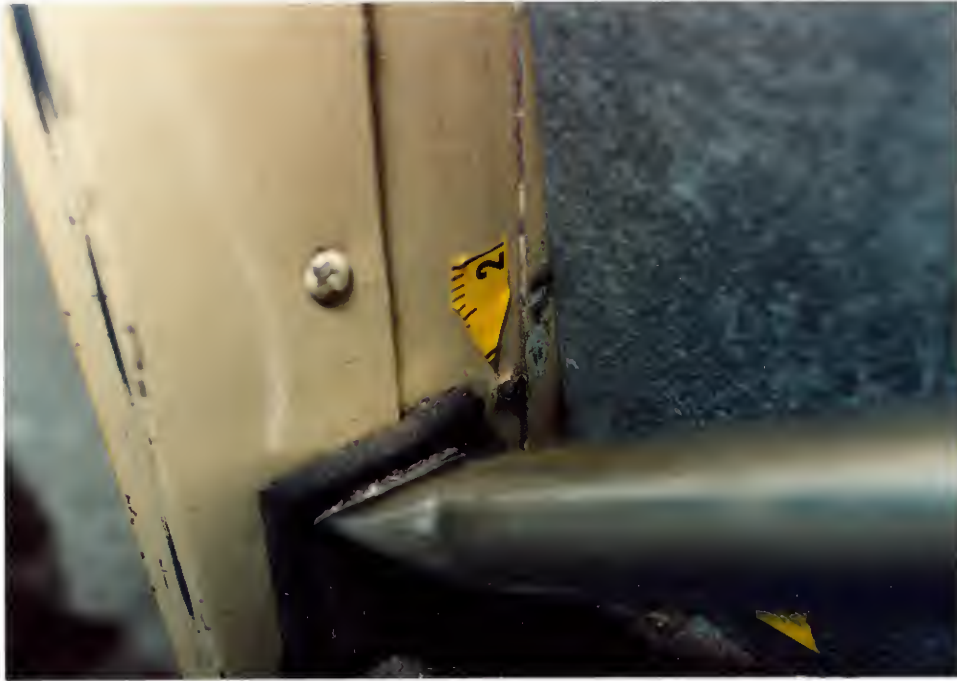
43. Former sheetmetal screw hole with exposed burrs from the initial installation of the kick panel.

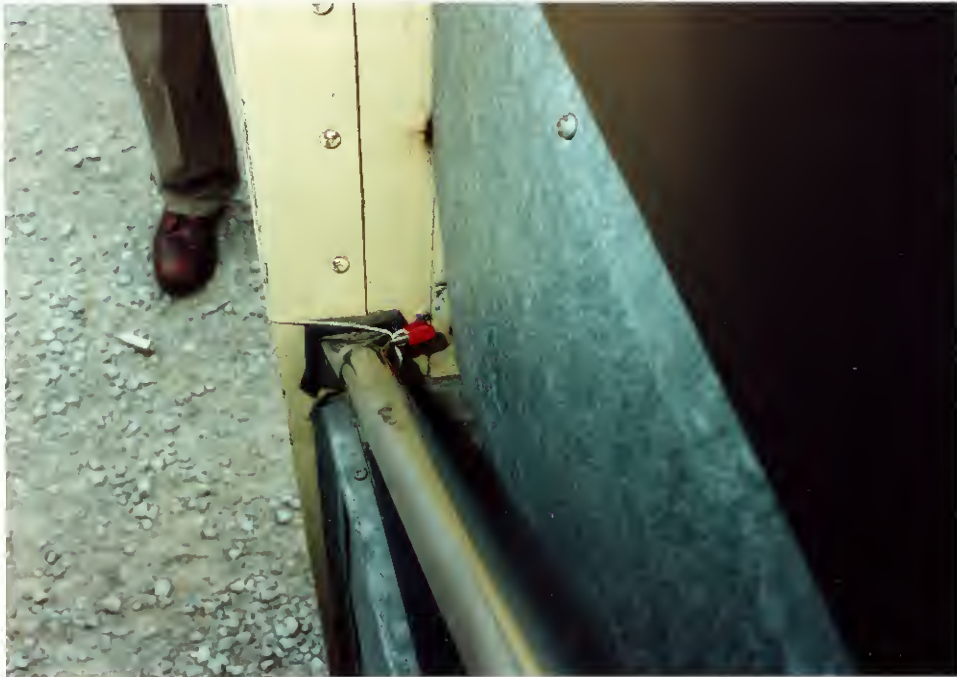
There were two possible components that could have allowed the drawstring to become caught in the bus. The components are the door/V-channel and the base of the handrail. The handrail was ruled out as a possible mechanism by two sources; the bus driver's statement that he observed the jacket (drawstring) fall as he opened the door and the inability to recreate a snagging of the actual drawstring following numerous tests over the handrail configuration. The large tab and the rounded corners on the tab prevented the drawstring from becoming snagged on the rail. The modified foam rubber pad contributed in deflecting the tab away from a possible snag point. Another style of drawstring tab could become snagged between the rail and the previously identified screw hole as documented in Photograph Nos. 44 and 45.

44. A "drawstring" constructed from chalkline and an alligator clip became snagged between the bottom of the handrail and the burrs at the screw hole on the first test.

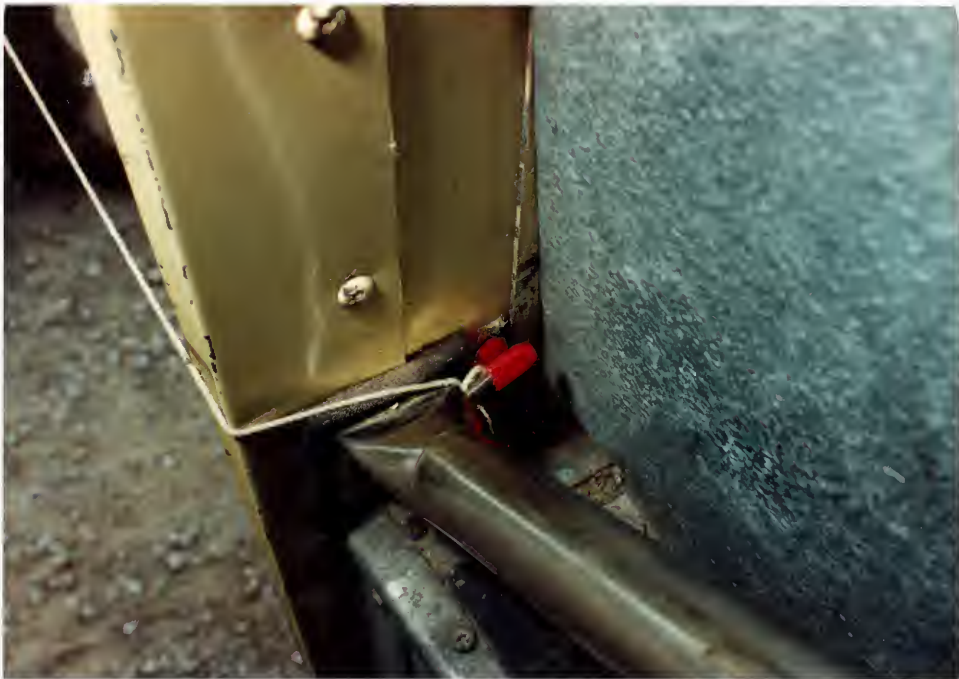
During the inspection process of the school bus, a simulated drawstring was constructed from a length of 0.125" diameter chalkline and a 1.25" (length) alligator clip. This drawstring was dragged along the modified handrail and on the first attempt, it snagged between the bottom of the rail and the screw hole in the side surface of the bus. Following additional attempts, the snagging was achieved on several tests as depicted in Photograph Nos. 44 and 45. The drawstring from the pedestrian's jacket would not snag at this location following numerous attempts.

45. Close-up view of the snagged alligator clip.
(The actual drawstring and adjustment tab from this accident would not snag at this point following numerous attempts.)

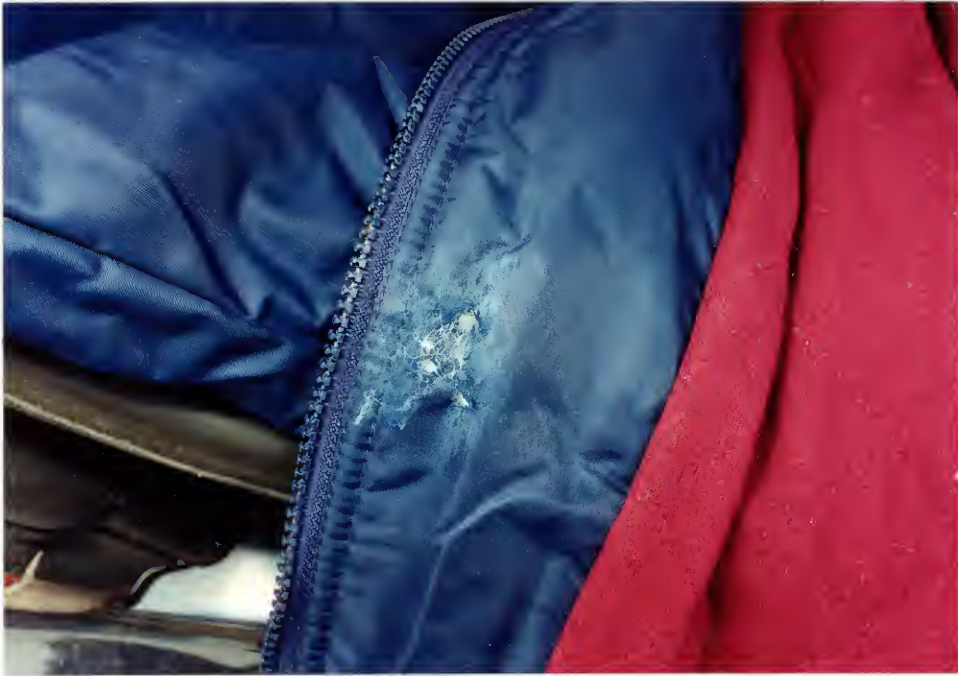
49. Abrasion to the right inner surface of the jacket from probable road surface contact.

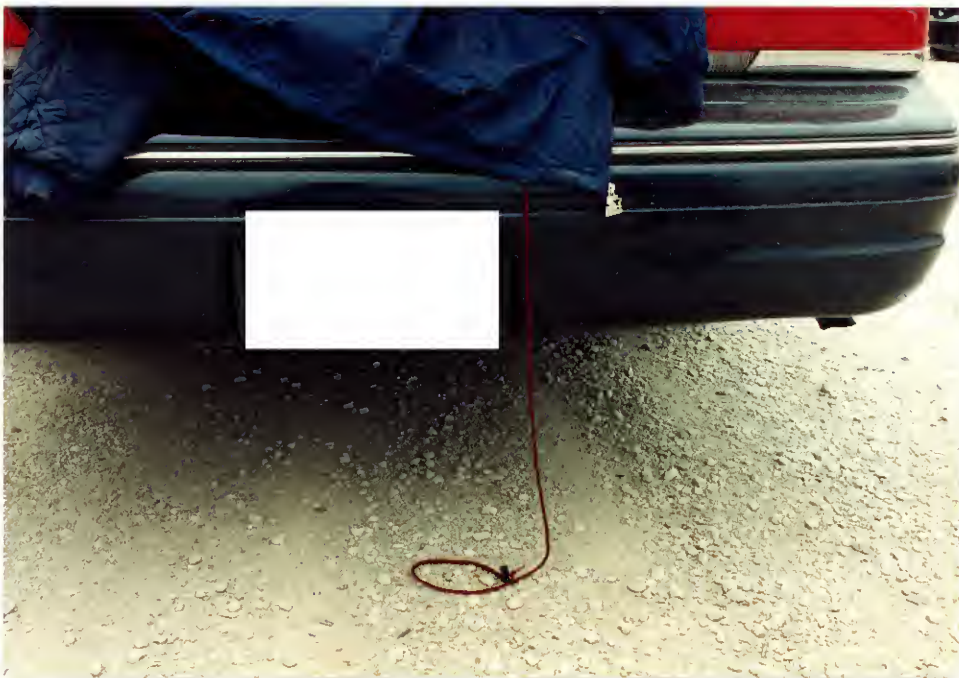
50. Full length of the drawstring (41") which was pulled out of the right side of the jacket.

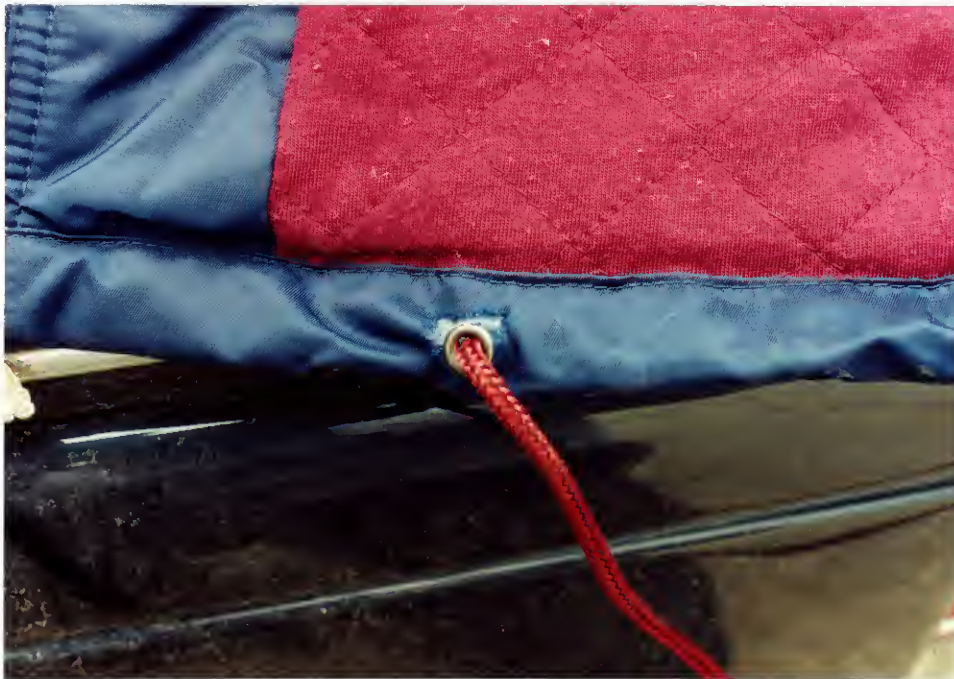
51. Torn fabric around the right side grommet of the jacket.

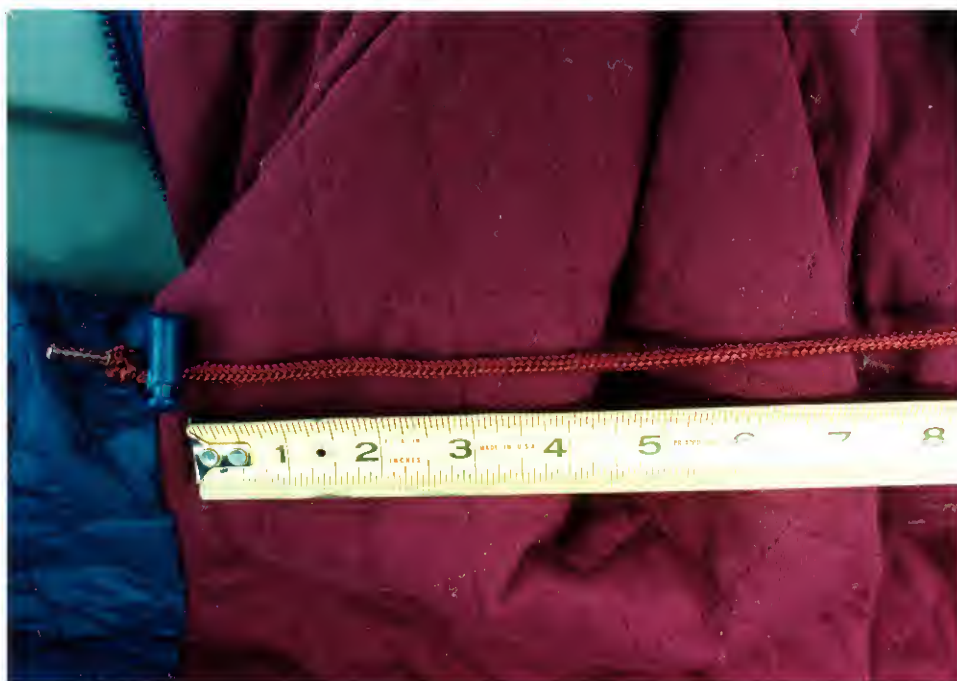
The inspection of the pedestrian's jacket indicated that the plastic tab on the end of the right drawstring was pulled against the knot at the end of the string and that the loop in the knot was pulled tight. The plastic tab was also deformed at the centerline of the tab adjacent to the hole for the drawstring. The tab and drawstring remained intact and attached to the jacket. There was an abrasion on the drawstring 5.5-6" inboard of the tab. There appeared to be a small chip of yellow

58. Snag with a possible paint chip in the drawstring at 5.5-6.0" above the adjustable tab.

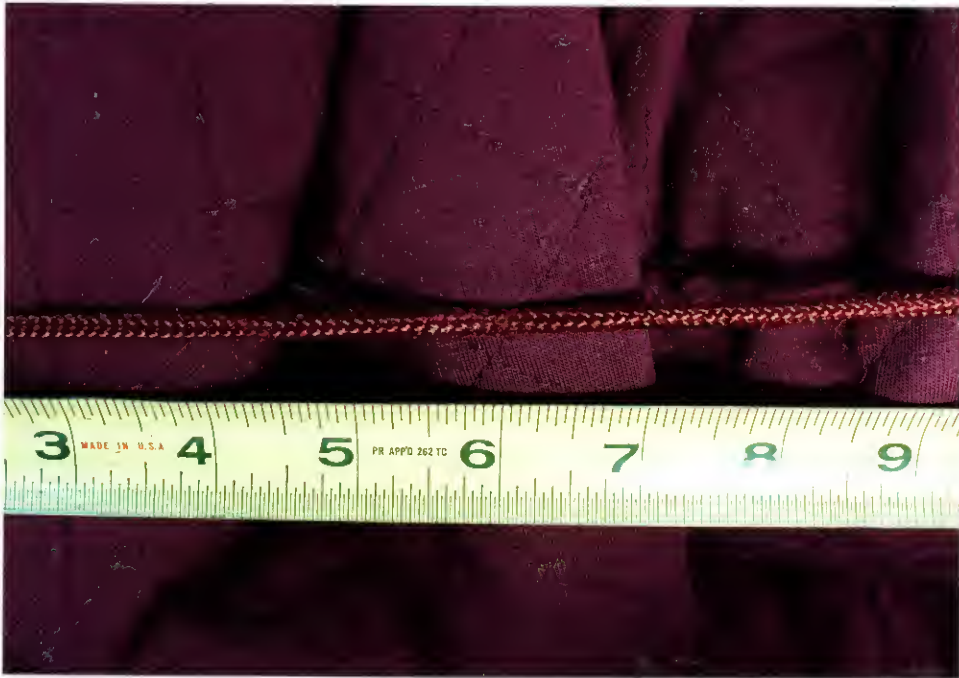
59. Close-up view of the drawstring snag.

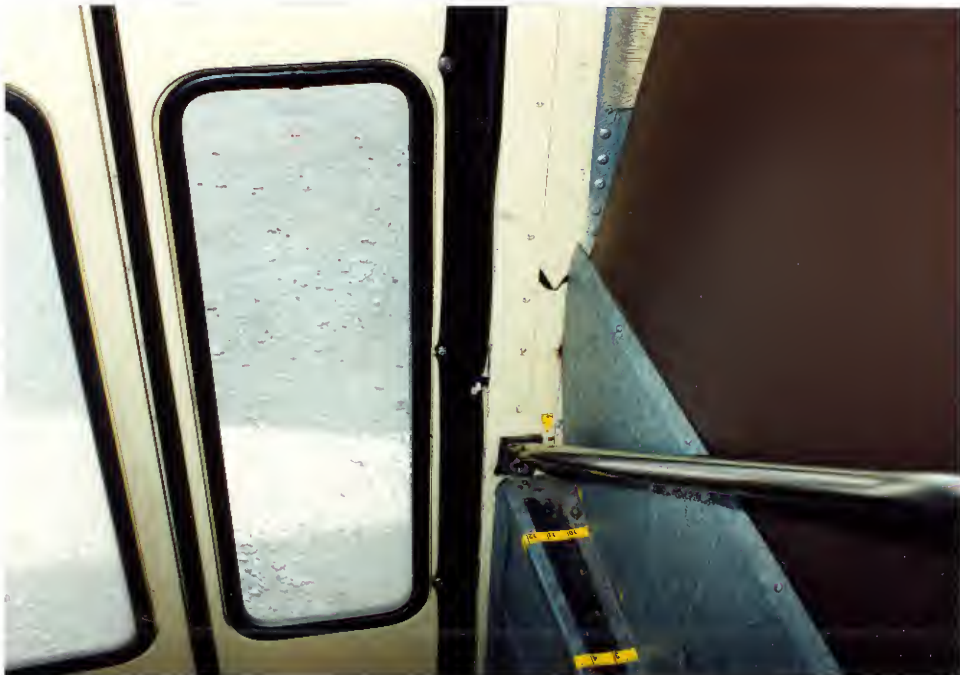
Using a similar style cord of the same diameter to represent the actual drawstring and an identical tab from the hood of the jacket, numerous tests were performed to recreate the snagging of the drawstring between the door gasket and the V-channel. With the drawstring extended through the door opening, the door was fully closed against the cord. A spring scale was used to measure the pull force required to disengage the drawstring and tab from the door. On the first test, the cord was pulled at an angle that was approximately perpendicular to the side surface of the bus. It required approximately 25 lbs. of force to pull the tab through the gasket to the center point of the V-channel and approximately 90 lbs. of force to disengage the drawstring from the closed door. Subsequent tests required approximately 75, 75, and 55 lbs. of force to pull the drawstring tab through the rubber gasket.

60. Recreation of the drawstring tab caught between the door and the V-channel.

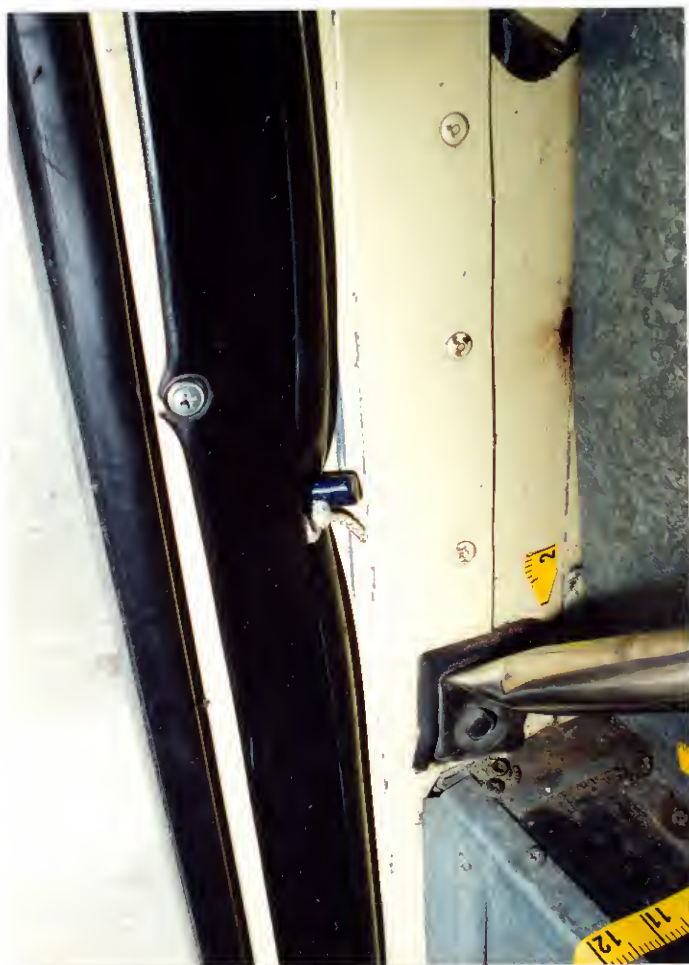
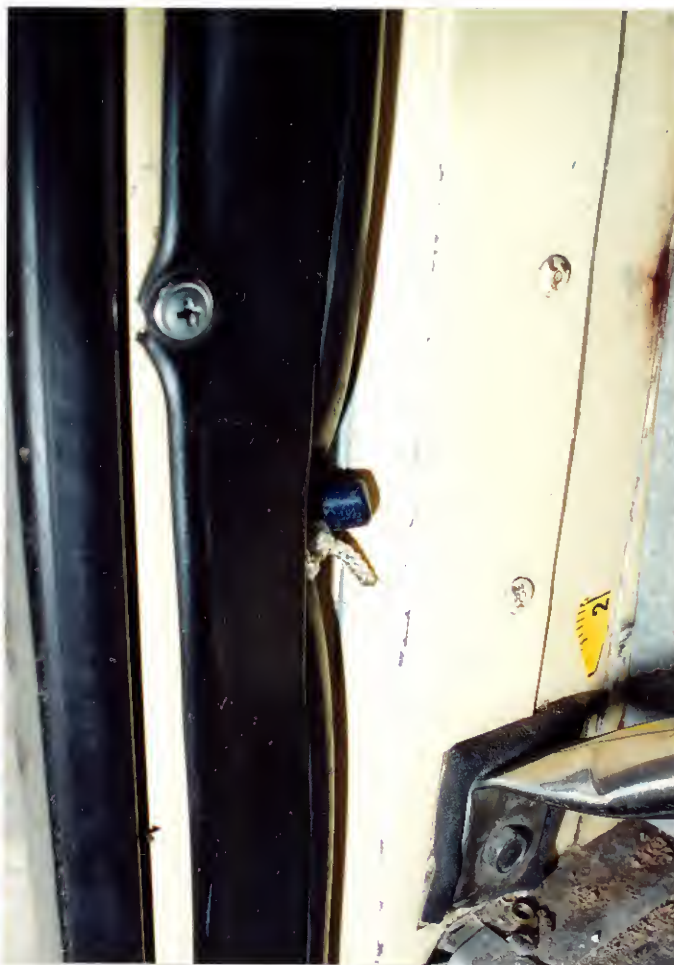
61. & 62. Close-up views of the drawstring tab caught between the door and the V-channel.

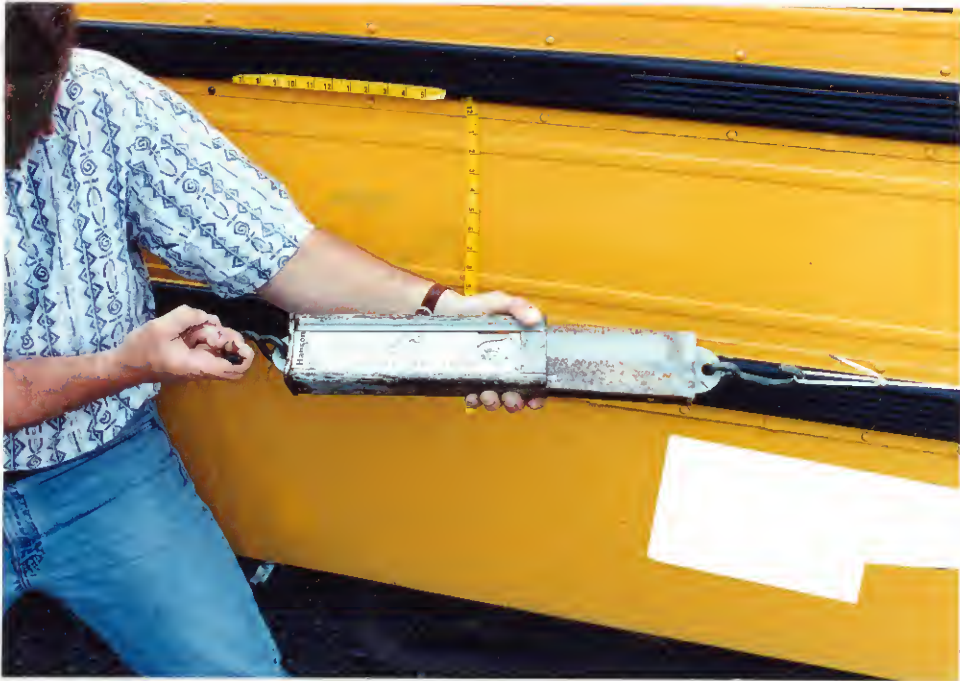
Additional pull tests were performed with the cord extended parallel to the side surface of the bus which represented the actual scenario for this accident. A police officer was positioned inside the school bus to operate the door while another officer recorded the tests photographically. On the first pull test parallel to the side surface of the bus, the spring scale bottomed out at 100 lbs. The officer positioned on the interior of the bus observed that the drawstring tab had remained in a horizontal attitude as it engaged with the center of the V-channel. The spring scale was removed from the cord and the Calspan investigator pulled with maximum effort on the cord in an attempt to disengage the tab from the door. Following several attempts, the tab remained firmly caught between

67. Pull force exceeding 100 lbs. as recorded on spring scale.

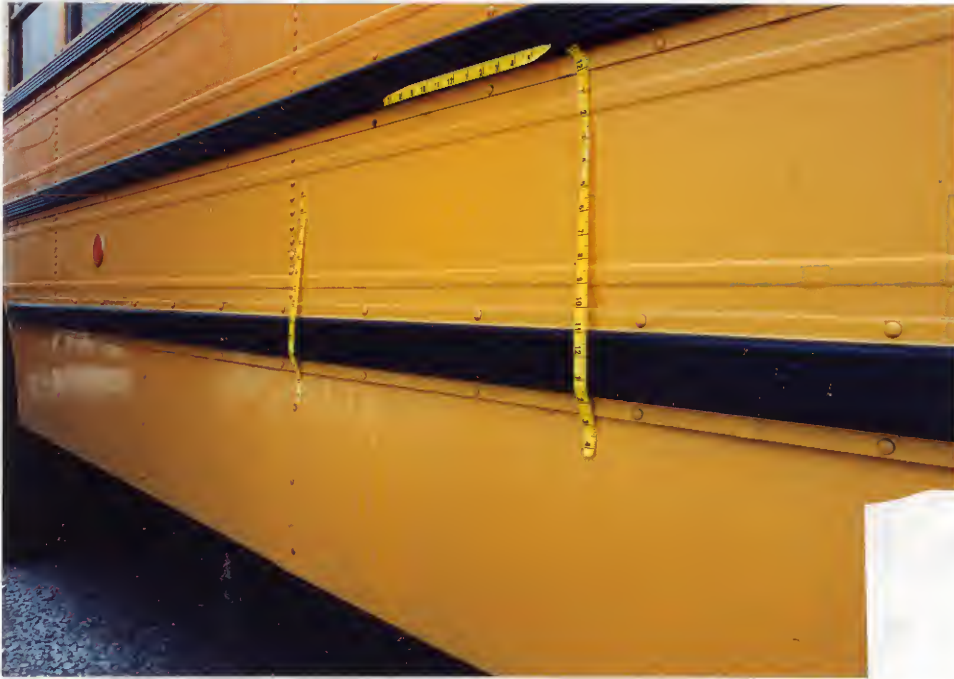
69. Pedestrian's right hand wipe mark on side surface of bus.
Wipe mark was located 74.5-90.25" rearward of the B-pillar.

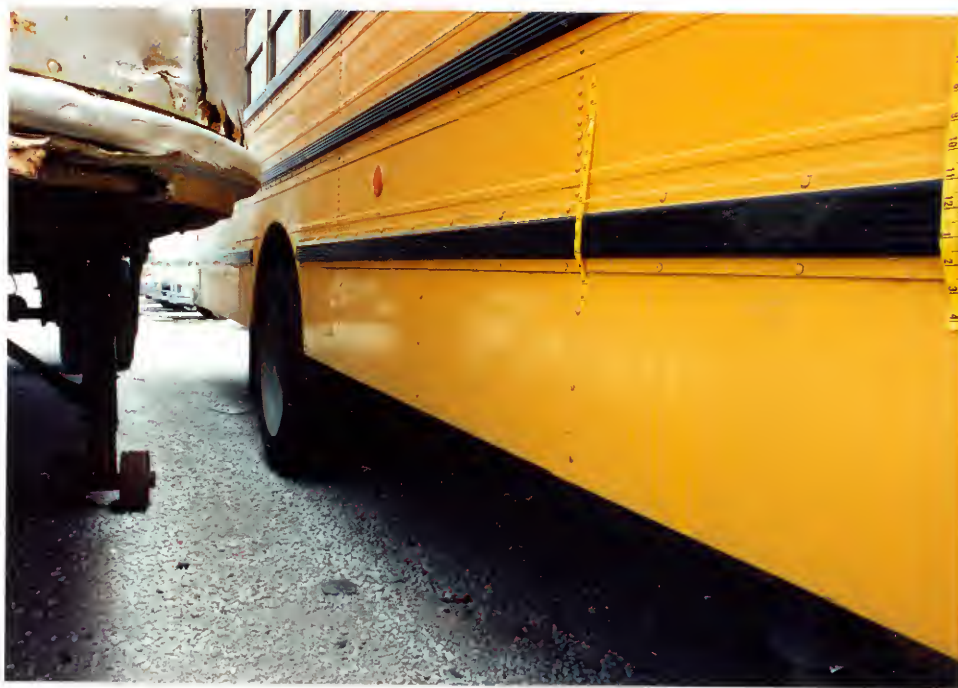
72. Right rear dual wheels which ran over the pedestrian.
